# SERVICE INFORMATION LETTER

**No: SIRS/SIL-CE2-A25-01 Rev.04**

**NAVIGATION - STANDBY NAVIGATION SYSTEMS –**

**STANDBY COMPASS - LAMP CAP ASSEMBLY –**

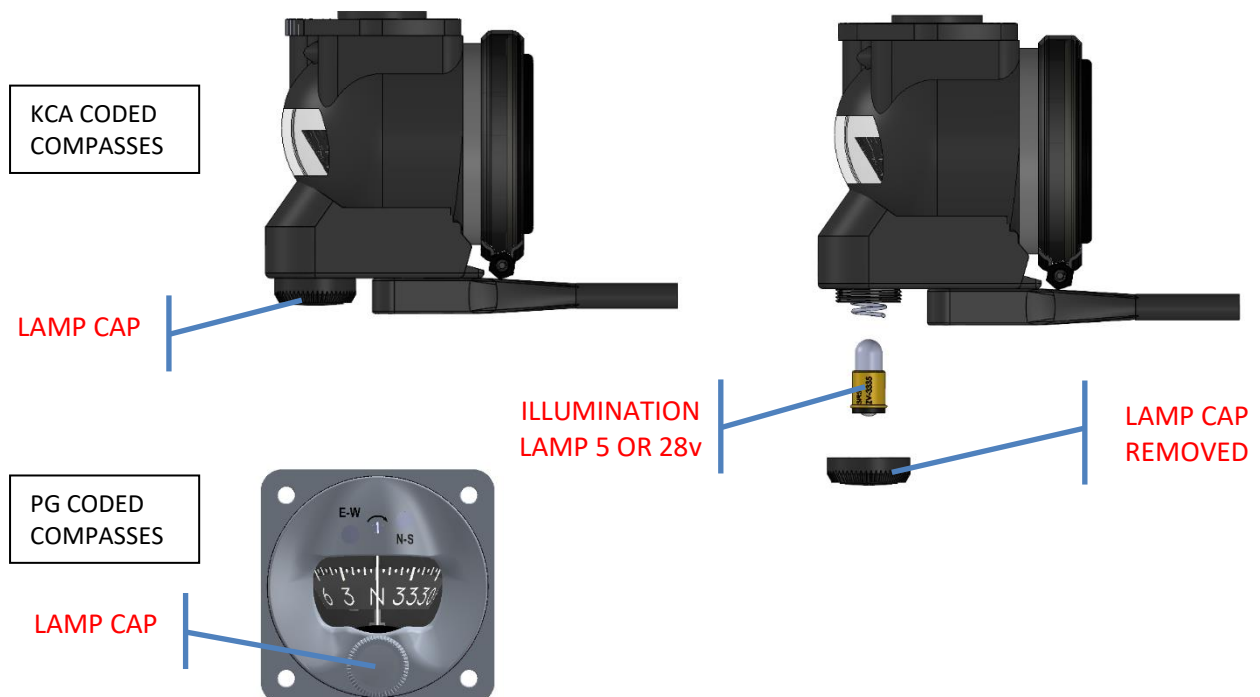
An occurrence\* has been reported to SIRS whereby the removal of an illumination lamp, **without immediate replacement**, has led to the local increase in temperature to adjacent compass components with subsequent plastic deformation. The problem will only occur with the power supply switched ‘ON’ and the illumination lamp **NOT Fitted**.

The absence of the replacement lamp will cause a decrease in circuit resistance and provide a 'short circuit', with potential power demand shown within table 1.0 below.
